**Flood Control Project Maintenance
Levee Inspections**
LMA District Cover Sheet
Spring 2017 Levee Inspection Results

Reclamation District No. 2094 Wathal

Levee Inspection Report By Mile - Spring 2017

Waterway	Bank	Unit Miles	Inspection Start/End	Inspector
Unit No. 01 San Joaquin River	Right	2.78	04/11/2017 04/11/2017	Maksim Khashchuk

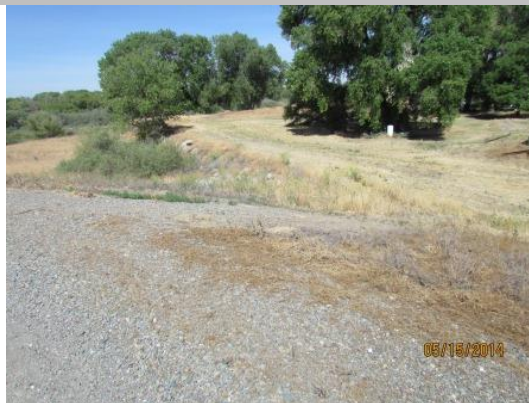
Photo 1 of 1 : SP_2017_RD2094_320_4_20170407_00001.jpg

LM Start	0.10	Rating **	M	Issue No.	4
LM End	0.10	Issue Type +	En	Location *	WS
Category	Earthen Levee			GPS Latitude/Longitude	
				Start	End
Item	Encroachments			37.771685 °	37.771685 °
				-121.300239 °	-121.300239 °
DWR ID	DWR_RD2094_01_s_2012_4				
Comment Code					
RA : Ramp					
Inspector Comment					
An access ramp has been built on the water side and extends into the channel. This could potentially alter the channel capacity. This item was also noted in the USACE comments.

Tire marks shown onto the ramp from levee. Raised area extends to the trees in the background in the center of the photo.

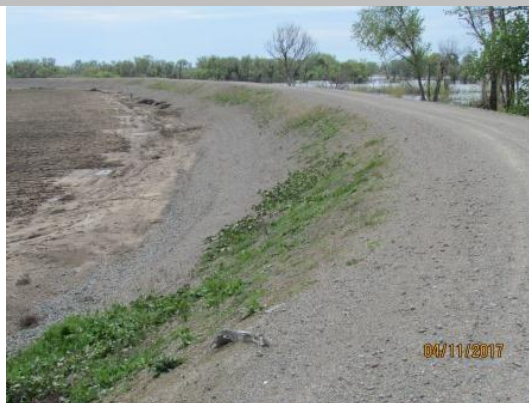
Photo 1 of 1 : SP_2017_RD2094_320_7_20170417_00014.jpg

LM Start	0.24	Rating **	A	Issue No.	7
LM End	2.76	Issue Type +	Ma	Location *	LS
Category	Earthen Levee			GPS Latitude/Longitude	
				Start	End
Item	Vegetation			37.769732 °	37.749741 °
				-121.301215 °	-121.289034 °
DWR ID	DWR_RD2094_01_s_2017_7				
Comment Code					
V1 : Control annual grass and weeds on the levee slopes and easements.					
Inspector Comment					
Acceptable vegetation control.

View of the acceptable vegetation control on the levee slope.

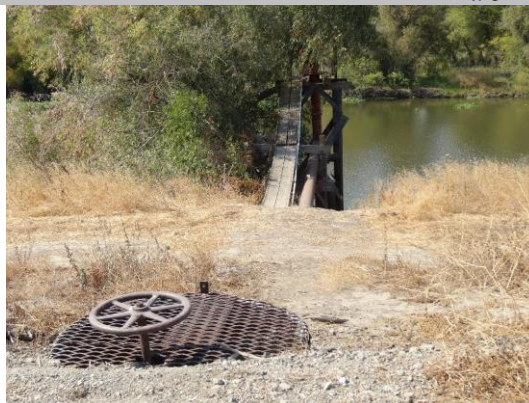
Photo 1 of 3 : UCIP_SP_2017_21464_36405.jpg

LM Start	0.65	Rating **	M	Issue No.	13
LM End	0.65	Issue Type +	En	Location *	LS
Category	Supplemental			GPS Latitude/Longitude	
				Start	End
Item	DWR UCIP Field Study			37.767514 °	37.767514 °
				-121.294926 °	-121.294926 °
DWR ID					
Comment Code					
Inspector Comment					
FS_ID:21464					
DS_ID:23086					
EP_NO: N/A					
Repair Type: Non-Urgent					
Crossing Status: Found					
UCIP Comments: - walkway in poor condition and needs repair.- electric conduit on waterside.					
FIELD_STRUCT_DESC: 14-inch concrete encased steel pipe and GI conduit through the levee, 10.0 feet below the crown, pump mounted on a pile structure in the stream, slide gate, 54-inch corrugated metal pipe riser on the waterward shoulder, concrete distribution box and service pole on the landward toe, installed by USCE, 1962 (O&M Unit No. 3, 1968)					
FS Date: 9/10/2013

WS view: gate valve in CMP riser (bottom) and pipe & pump (top) on piling structure in the channel.

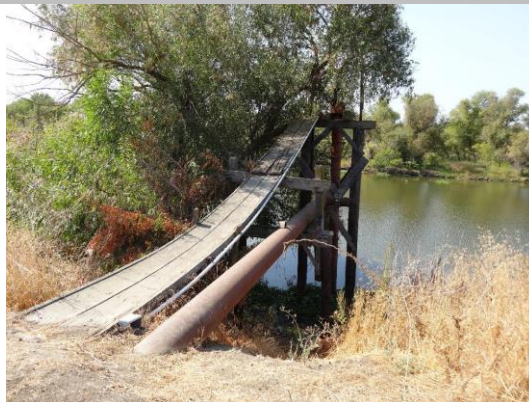
Photo 2 of 3 : UCIP_SP_2017_21464_36404.jpg

WS view: pump on piling structure in the channel. Pipe (right- bottom) and conduit (bottom- left).

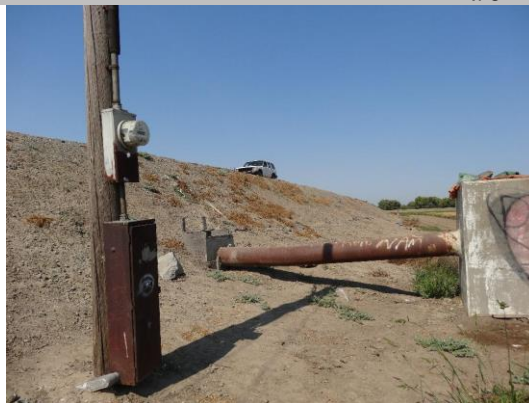
Photo 3 of 3 : UCIP_SP_2017_21464_36403.jpg

LM Start	0.65	Rating **	M	Issue No.	13 (cont)	
LM End	0.65	Issue Type +	En	Location *	LS	
Category	Supplemental			GPS Latitude/Longitude		
				Start		End
Item	DWR UCIP Field Study			37.767514 °	37.767514 °	
				-121.294926 °	-121.294926 °	
DWR ID						
Comment Code						
Inspector Comment						
FS_ID:21464						
DS_ID:23086						
EP_NO: N/A						
Repair Type: Non-Urgent						
Crossing Status: Found						
UCIP Comments: - walkway in poor condition and needs repair.- electric conduit on waterside.						
FIELD_STRUCT_DESC: 14-inch concrete encased steel pipe and GI conduit through the levee, 10.0 feet below the crown, pump mounted on a pile structure in the stream, slide gate, 54-inch corrugated metal pipe riser on the waterward shoulder, concrete distribution box and service pole on the landward toe, installed by USCE, 1962 (O&M Unit No. 3, 1968)						
FS Date: 9/10/2013

LS view: exposed pipe, service pole, and concrete distribution box on levee toe.

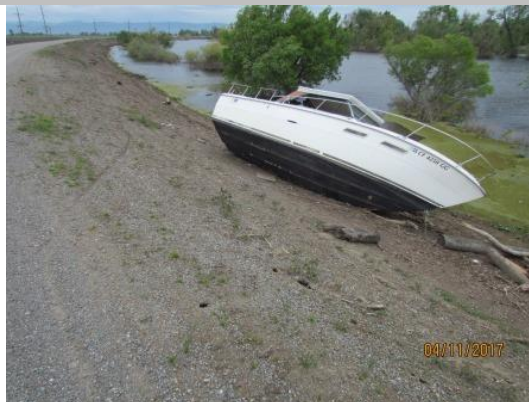
Photo 1 of 1 : SP_2017_RD2094_320_8_20170417_00015.jpg

LM Start	0.91	Rating **	M	Issue No.	8
LM End	0.91	Issue Type +	En	Location *	WS
Category	Earthen Levee			GPS Latitude/Longitude	
				Start	End
Item	Encroachments			37.764169 °	37.764169 °
				-121.293562 °	-121.293562 °
DWR ID	DWR_RD2094_01_s_2017_8				
Comment Code					
AV : Abandoned vehicles					
Inspector Comment					
Remove boat from the levee slope.

View of the boat on the levee slope.

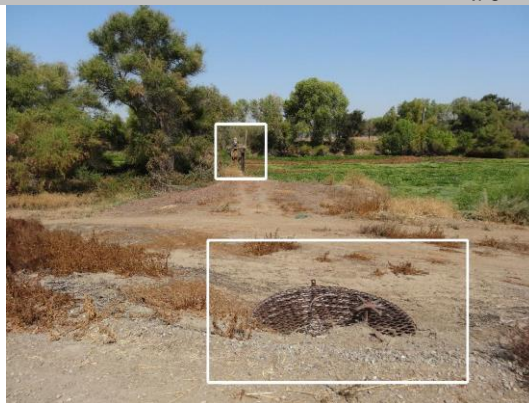
Photo 1 of 3 : UCIP_SP_2017_21544_36524.jpg

LM Start	1.25	Rating **	M	Issue No.	14
LM End	1.25	Issue Type +	En	Location *	WS
Category	Supplemental			GPS Latitude/Longitude	
				Start	End
Item	DWR UCIP Field Study			37.760581 °	37.760581 °
				-121.297373 °	-121.297373 °
DWR ID					
Comment Code					
Inspector Comment					
FS_ID:21544					
DS_ID:23087					
EP_NO: N/A					
Repair Type: Non-Urgent					
Crossing Status: Found					
UCIP Comments: - working as drainage system during field visit. Pump was not running.- electric conduit on WS- open pipe end in CMP riser. CMP needs cleaning.					
FIELD_STRUCT_DESC: 20-inch concrete encased steel pipe through the levee, 10.0 feet below the crown, pump mounted on a pile structure in the stream, gate valve, 54-inch corrugated metal pipe riser on the waterward shoulder, concrete distribution box and service pole on the landward toe (O&M Unit No. 3, 1968)					
FS Date: 9/10/2013

WS view: overview of pump (top) and CMP riser (bottom)

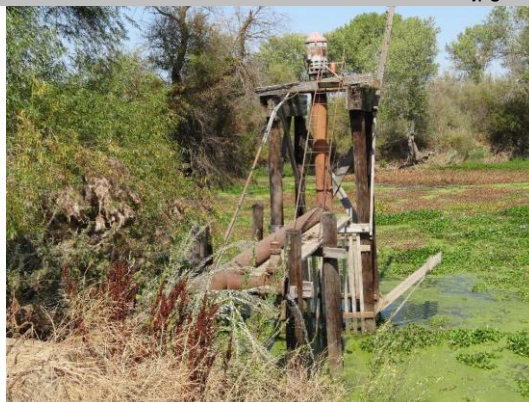
Photo 2 of 3 : UCIP_SP_2017_21544_36523.jpg

WS view: pipe and pump on piling structure in the channel. Walkway in poor condition.

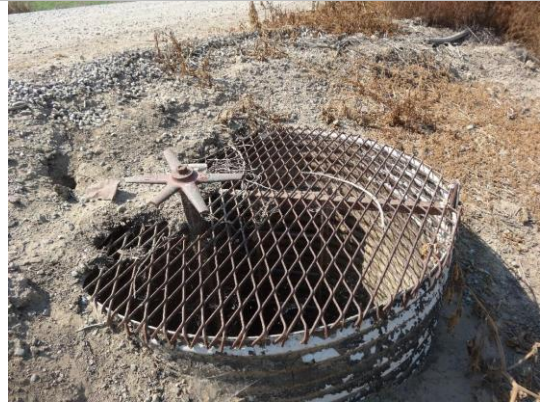
Photo 3 of 3 : UCIP_SP_2017_21544_36522.jpg

LM Start	1.25	Rating **	M	Issue No.	14 (cont)
LM End	1.25	Issue Type +	En	Location *	WS
Category	Supplemental			GPS Latitude/Longitude	
				Start	End
Item	DWR UCIP Field Study			37.760581 °	37.760581 °
				-121.297373 °	-121.297373 °
DWR ID					
Comment Code					
Inspector Comment					
FS_ID:21544					
DS_ID:23087					
EP_NO: N/A					
Repair Type: Non-Urgent					
Crossing Status: Found					
UCIP Comments: - working as drainage system during field visit. Pump was not running.- electric conduit on WS- open pipe end in CMP riser. CMP needs cleaning.					
FIELD_STRUCT_DESC: 20-inch concrete encased steel pipe through the levee, 10.0 feet below the crown, pump mounted on a pile structure in the stream, gate valve, 54-inch corrugated metal pipe riser on the waterward shoulder, concrete distribution box and service pole on the landward toe (O&M Unit No. 3, 1968)					
FS Date: 9/10/2013

WS view: damaged gate valve handle in CMP riser on levee shoulder.

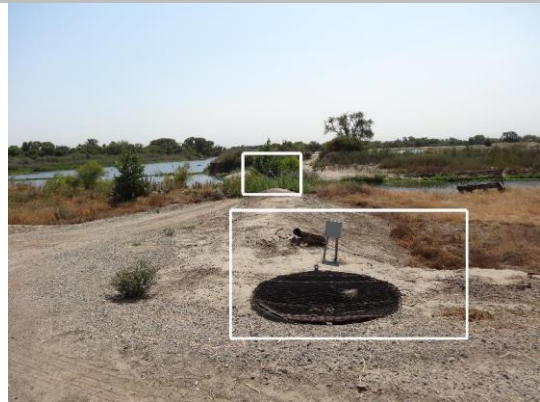
Photo 1 of 3 : UCIP_SP_2017_41726_36502.jpg

LM Start	2.25	Rating **	M	Issue No.	15
LM End	2.25	Issue Type +	En	Location *	WS
Category	Supplemental			GPS Latitude/Longitude	
				Start	End
Item	DWR UCIP Field Study			37.752230 °	37.752230 °
				-121.296408 °	-121.296408 °
DWR ID					
Comment Code					
Inspector Comment					
FS_ID:41726 DS_ID:23088 EP_NO: N/A Repair Type: Non-Urgent Crossing Status: Found UCIP Comments: - dense vegetation on WS.- working during field survey.- slide gate not found on WS. FIELD_STRUCT_DESC: 20-inch concrete encased steel pipe through the levee, 6.0 feet below the crown, slant pump mounted on a frame structure on the stream bank, 54-inch corrugated metal pipe riser on the waterward shoulder, concrete distribution box and service pole on the landward toe (O&M Unit No. 3, 1968) FS Date: 9/10/2013

WS view: slant pump (top) on stream bank and CMP riser on levee shoulder.

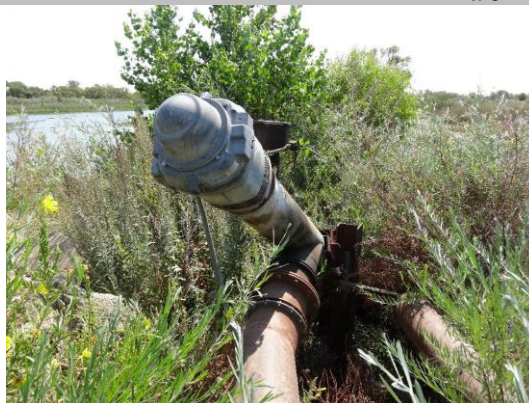
Photo 2 of 3 : UCIP_SP_2017_41726_36501.jpg

LM Start	2.25	Rating **	M	Issue No.	15 (cont)
LM End	2.25	Issue Type +	En	Location *	WS
Category	Supplemental			GPS Latitude/Longitude	
				Start	End
Item	DWR UCIP Field Study			37.752230 °	37.752230 °
				-121.296408 °	-121.296408 °
DWR ID					
Comment Code					
Inspector Comment					
FS_ID:41726 DS_ID:23088 EP_NO: N/A Repair Type: Non-Urgent Crossing Status: Found UCIP Comments: - dense vegetation on WS.- working during field survey.- slide gate not found on WS. FIELD_STRUCT_DESC: 20-inch concrete encased steel pipe through the levee, 6.0 feet below the crown, slant pump mounted on a frame structure on the stream bank, 54-inch corrugated metal pipe riser on the waterward shoulder, concrete distribution box and service pole on the landward toe (O&M Unit No. 3, 1968) FS Date: 9/10/2013

WS view: slant pump on stream bank and dense vegetation on stream bank.

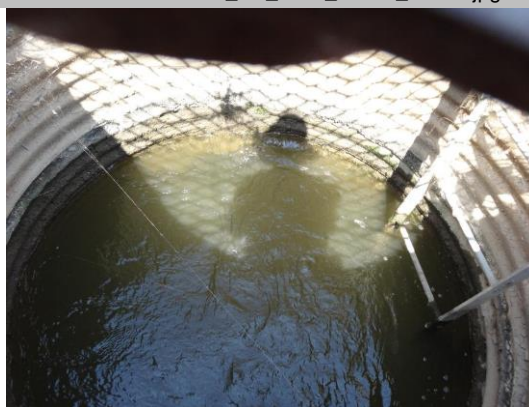
Photo 3 of 3 : UCIP_SP_2017_41726_36500.jpg

WS view: inside view of CMP riser on levee shoulder. No slide gate found.

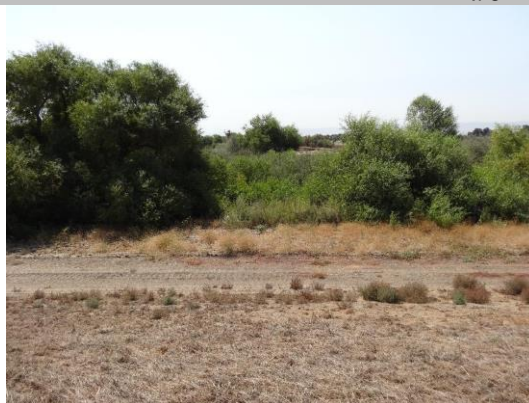
Photo 1 of 3 : UCIP_SP_2017_21545_36529.jpg

LM Start	2.45	Rating **	M	Issue No.	16
LM End	2.45	Issue Type +	En	Location *	WS
Category	Supplemental			GPS Latitude/Longitude	
				Start	End
Item	DWR UCIP Field Study			37.752308 °	37.752308 °
				-121.293191 °	-121.293191 °
DWR ID					
Comment Code					
Inspector Comment					
FS_ID:21545 DS_ID:23089 EP_NO: N/A Repair Type: Non-Urgent Crossing Status: Found UCIP Comments: - no pipes found on either side of the levee.- concrete distribution box on LS. Soil erosion around distrinution box. FIELD_STRUCT_DESC: Rectangular concrete distribution box on the landward toe FS Date: 9/10/2013

WS view: no pipe found on waterside.

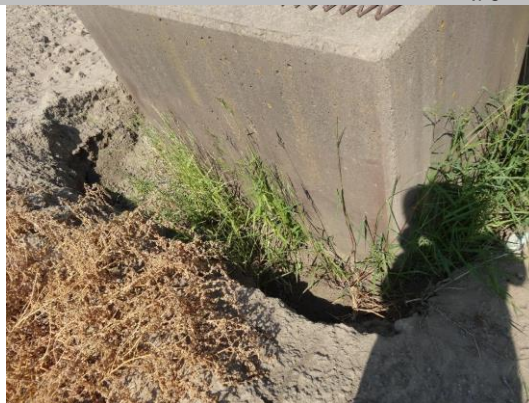
Photo 3 of 3 : UCIP_SP_2017_21545_36527.jpg

LM Start	2.45	Rating **	M	Issue No.	16 (cont)
LM End	2.45	Issue Type +	En	Location *	WS
Category	Supplemental			GPS Latitude/Longitude	
				Start	End
Item	DWR UCIP Field Study			37.752308 °	37.752308 °
				-121.293191 °	-121.293191 °
DWR ID					
Comment Code					
Inspector Comment					
FS_ID:21545 DS_ID:23089 EP_NO: N/A Repair Type: Non-Urgent Crossing Status: Found UCIP Comments: - no pipes found on either side of the levee.- concrete distribution box on LS. Soil erosion around distrinution box. FIELD_STRUCT_DESC: Rectangular concrete distribution box on the landward toe FS Date: 9/10/2013

LS view: erosion around a concrete standpipe on the landside toe.

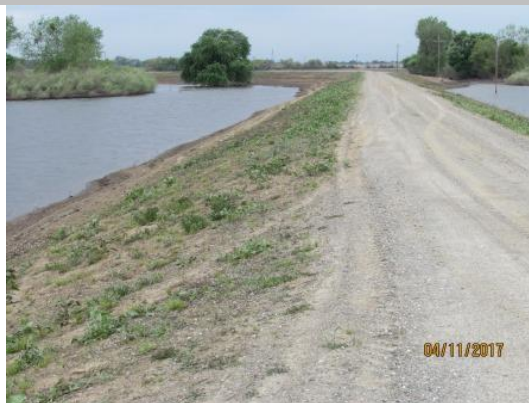
Photo 1 of 1 : SP_2017_RD2094_321_1_20170417_00001.jpg

LM Start	0.01	Rating **	A	Issue No.	1
LM End	0.44	Issue Type +	Ma	Location *	WS
Category	Earthen Levee			GPS Latitude/Longitude	
				Start	End
Item	Vegetation			37.759253 °	37.760602 °
				-121.299783 °	-121.307040 °
DWR ID	DWR_RD2094_02_s_2017_1				
Comment Code					
V1 : Control annual grass and weeds on the levee slopes and easements.					
Inspector Comment					
Acceptable vegetation control.

View of the acceptable vegetation on the levee slope.

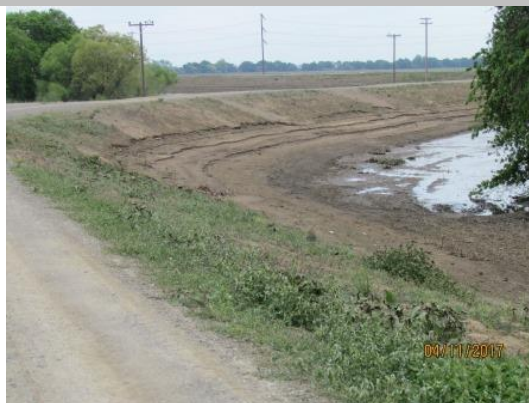
Photo 1 of 1 : SP_2017_RD2094_321_2_20170417_00002.jpg

LM Start	0.05	Rating **	M	Issue No.	2
LM End	0.22	Issue Type +	Ma	Location *	WS
Category	Earthen Levee			GPS Latitude/Longitude	
				Start	End
Item	Erosion / Bank Caving			37.759549 °	37.760616 °
				-121.300319 °	-121.303081 °
DWR ID	DWR_RD2094_02_s_2017_2				
Comment Code					
E2 : Schedule repair of erosion site prior to the next inspection.					
Inspector Comment

View of the wave wash erosion on the levee slope.
